CERTIFICATE OF APPROPRIATENESS**Application Date:** August 3, 2014**Applicant:** Michael & Laura Czapski, owners**Property:** 528 Highland Street, Lot 8 & Tract 7, Block 20, Woodland Heights Subdivision. The property includes a historic one-story residence situated on a 7,500 square foot (75' x 100') corner lot.**Significance:** Contributing Queen Anne residence with Colonial influence, constructed circa 1915, located in the Woodland Heights Historic District.**Proposal:** Alteration – Request for HAHC approval of completed and partially completed alterations that have exceeded the scope of work approved in two previous COAs.

The applicant received a COA in February 2014 for a two-story rear addition to a one-story contributing house. In March, the applicant was red-tagged for removing all of the shiplap from the original house without approval. He was granted a COA in April 2014 for this unapproved work.

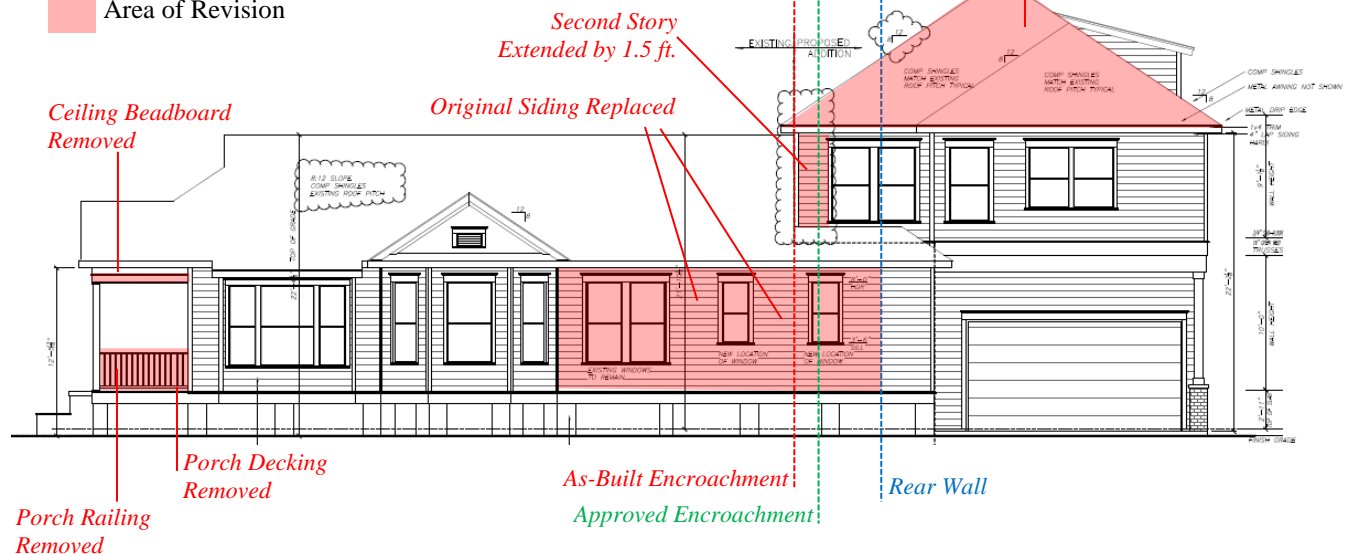
PROPOSED AUG.-SEPT. 2014 (AS BUILT)

Roof Pitch Altered and Ridge Height Increased by 2'

Area of Revision

- Structure taller than approved. Due to the increase in roof pitch, the actual ridge of the addition is 2'-1" taller than approved. The approved ridge height was 30'-5" while the structure currently has a height of 32'-6".

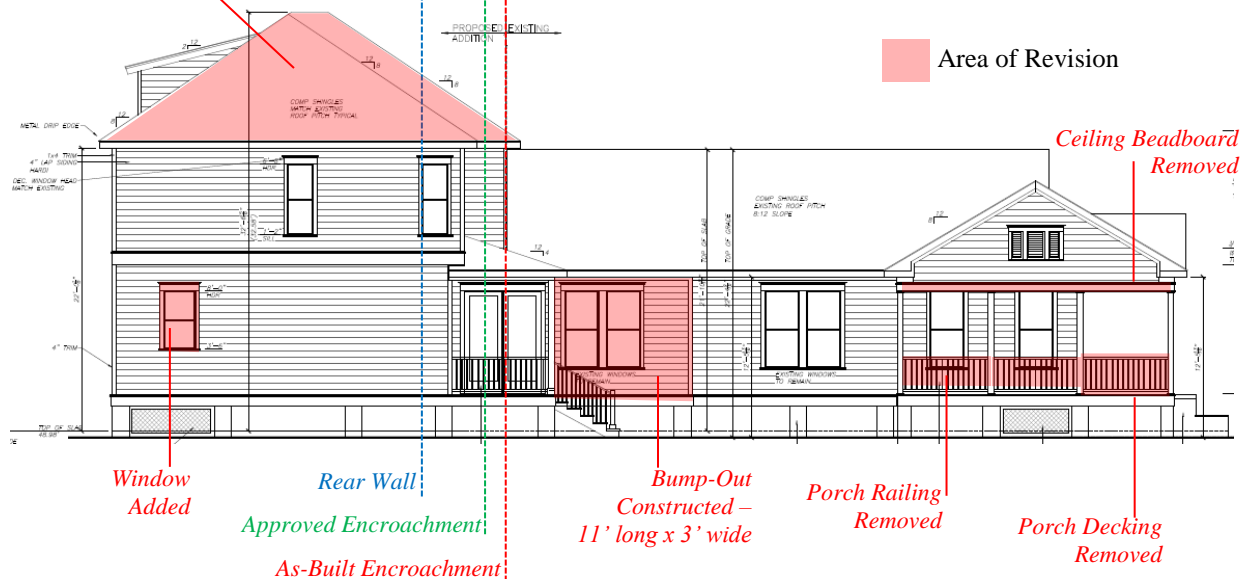
PROPOSED AUG.-SEPT. 2014 (AS BUILT)

*Roof Pitch Altered and
Ridge Height increased by 2'*

Area of Revision

*Ceiling Beadboard
Removed*

*Porch Railing
Removed*

*Porch Decking
Removed*

*Bump-Out
Constructed –
11' long x 3' wide*

As-Built Encroachment

Approved Encroachment

*Window
Added*

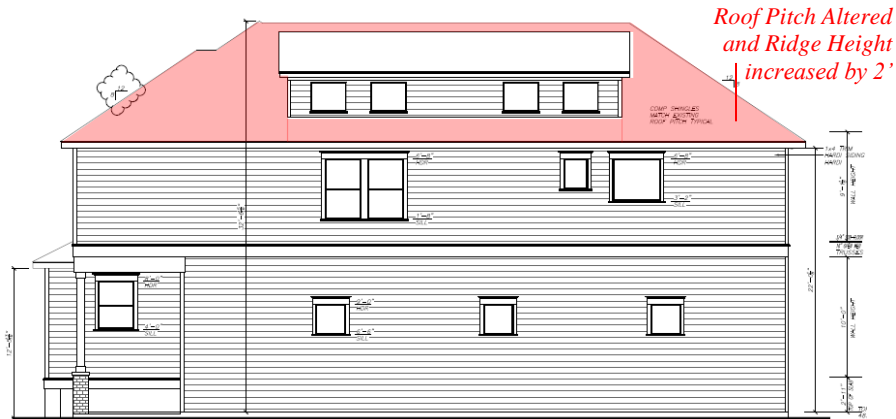
PROPOSED AUG.-SEPT. 2014 (AS BUILT)

*Roof Pitch Altered
and Ridge Height
increased by 2'*

Area of Revision

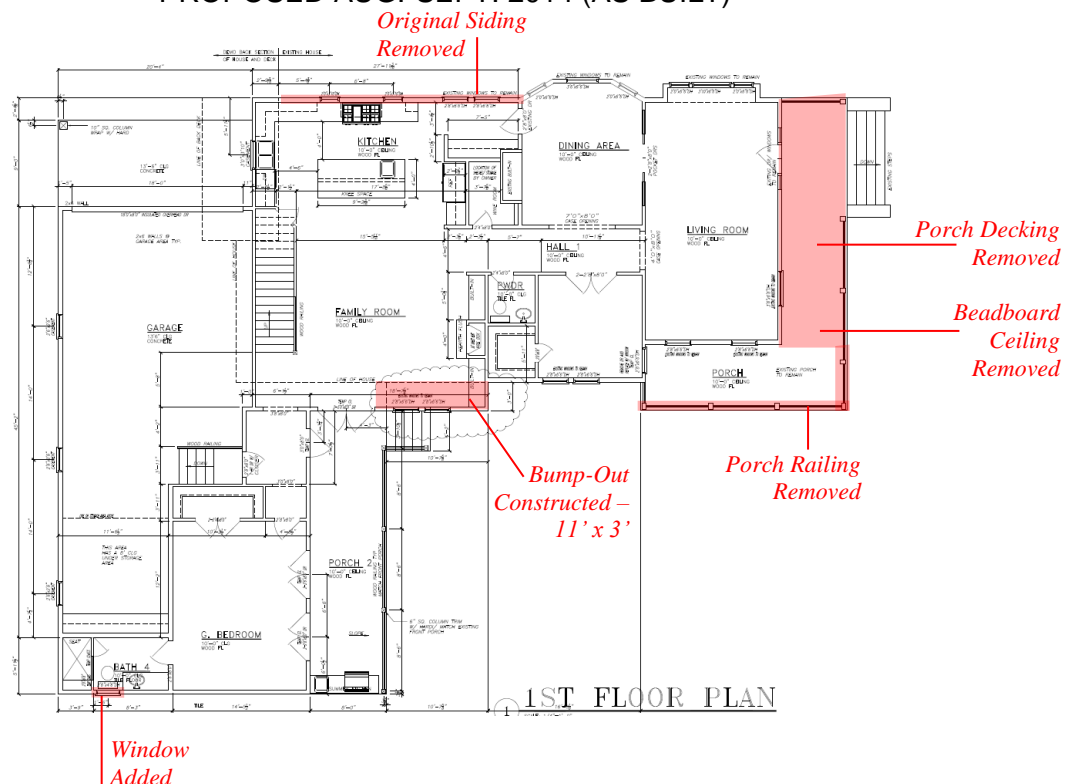
PROPOSED AUG.-SEPT. 2014 (AS BUILT)

Area of Revision

- Bump-out on east elevation. A 2'-10" wide by 10'-9" deep bump-out on the first-story of the original structure was constructed. In order to bump out the existing wall, historic material was destroyed. The original windows from the demolished wall have been installed in the bump-out.

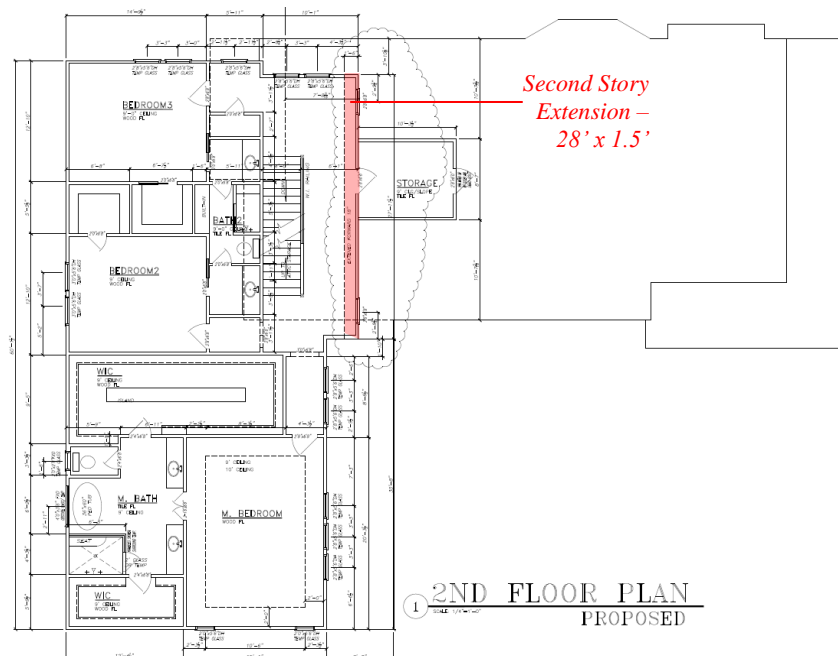
PROPOSED AUG.-SEPT. 2014 (AS BUILT)

Area of Revision

- The second story addition extends 18" farther onto the original house than approved. This encroachment runs for 28' along the front elevation. No explanation of why this happened has been provided.

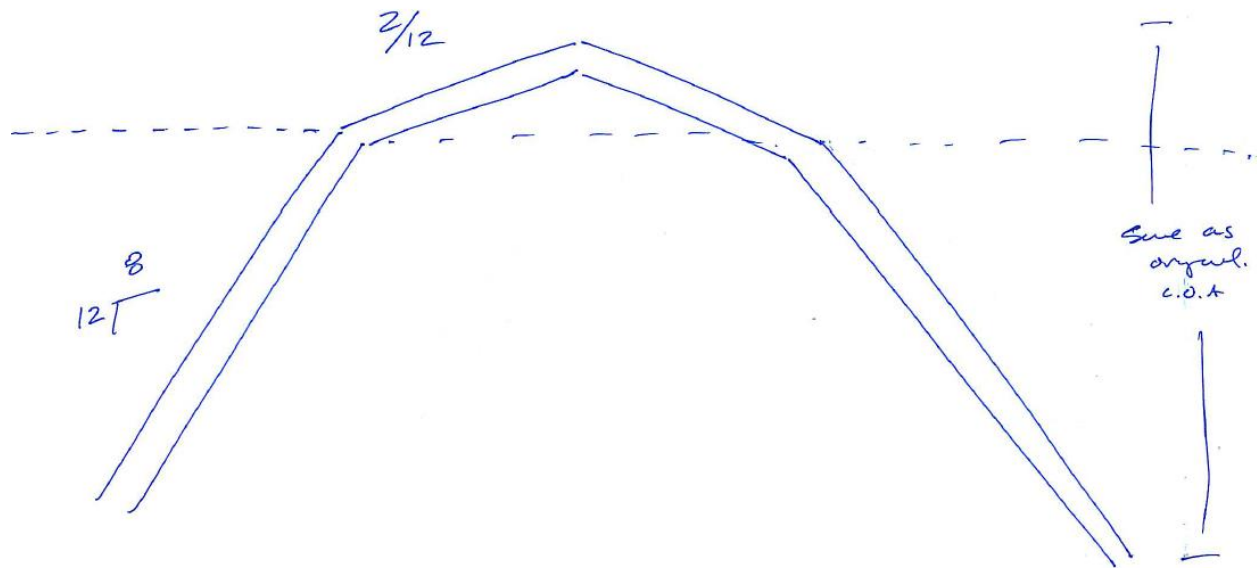
PROPOSED ROOF ALTERATION
TO LOWER ROOF HEIGHT BY TWO FEET

- The applicant has proposed an option to remove the top three feet of the current 8:12 roof and rebuild that portion at a 2:12 pitch to reduce the overall height by two feet. This proposed option would create a hipped gambrel roof. This plan, however, does not address the issues of the bump-outs and loss of material.

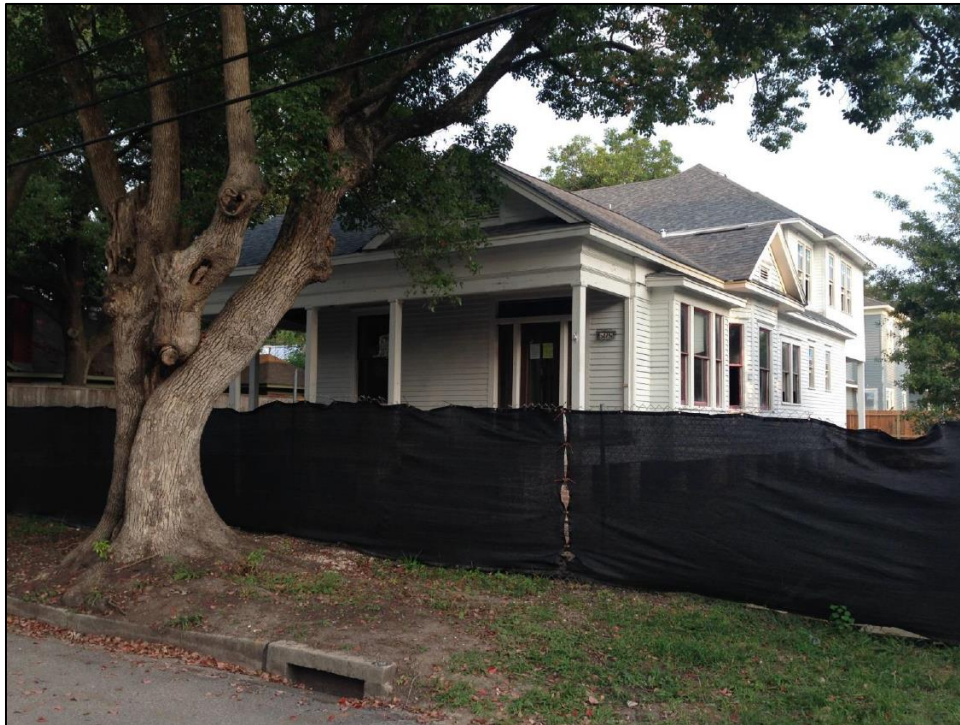
Applicant Photo; Gable removed (hipped)

- When roof shape discrepancy was discovered, and after a meeting in which staff advised the applicant to stop all work until a list of all unapproved work can be compiled, the applicant notified staff that his construction crew tore off the gable and constructed a hip.

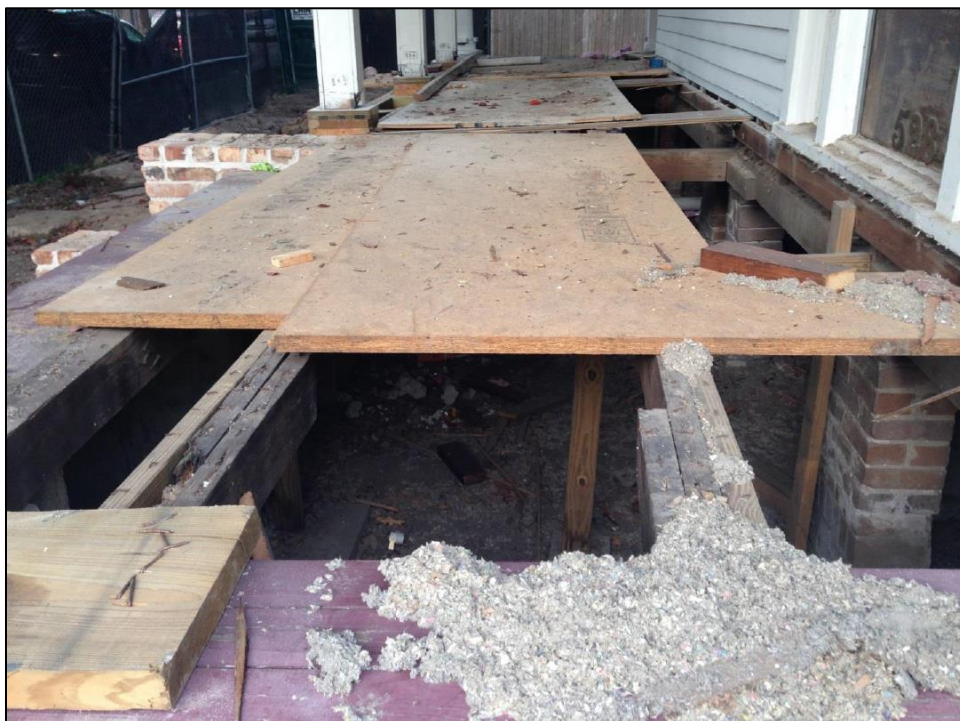
Applicant Photo; removed porch decking

The original front porch was removed without approval. The owner has agreed to appropriately reconstruct front porch elements to match original with in-kind materials. During construction, the original siding on the west elevation was removed and replaced with cementitious siding. The owner has also agreed to replace the cementitious siding with wood siding to match original up to the original rear wall of the house. Trim board will delineate the rear wall from the addition, which will feature cementitious siding with a 4" reveal.

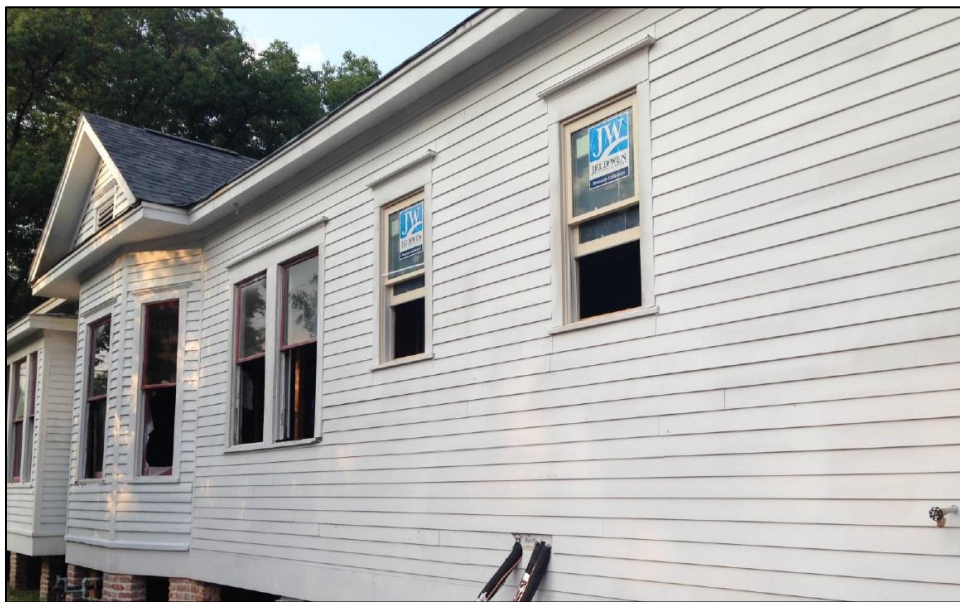
Applicant Photo; showing re-sided west wall

Applicant continued to work after notified to stop all unpermitted work

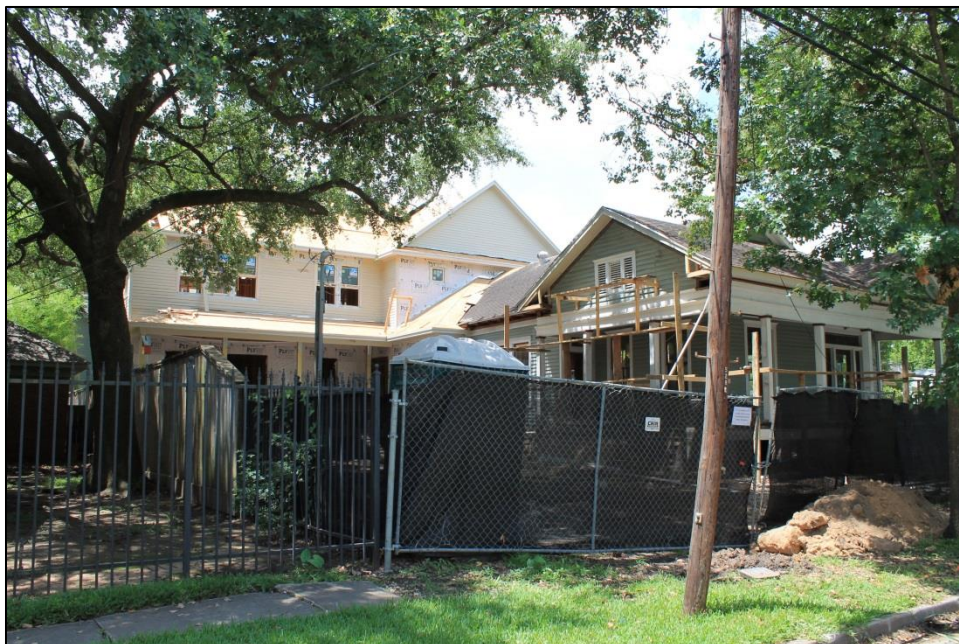
Staff Photo: 06/272014; Showing gable

- Constructed a front gable roof as opposed to a hipped roof. Inconsistencies were discovered with the approved stamped set of plans. Plans showed a hipped roof on all elevations and a gable roof on the roof plan.

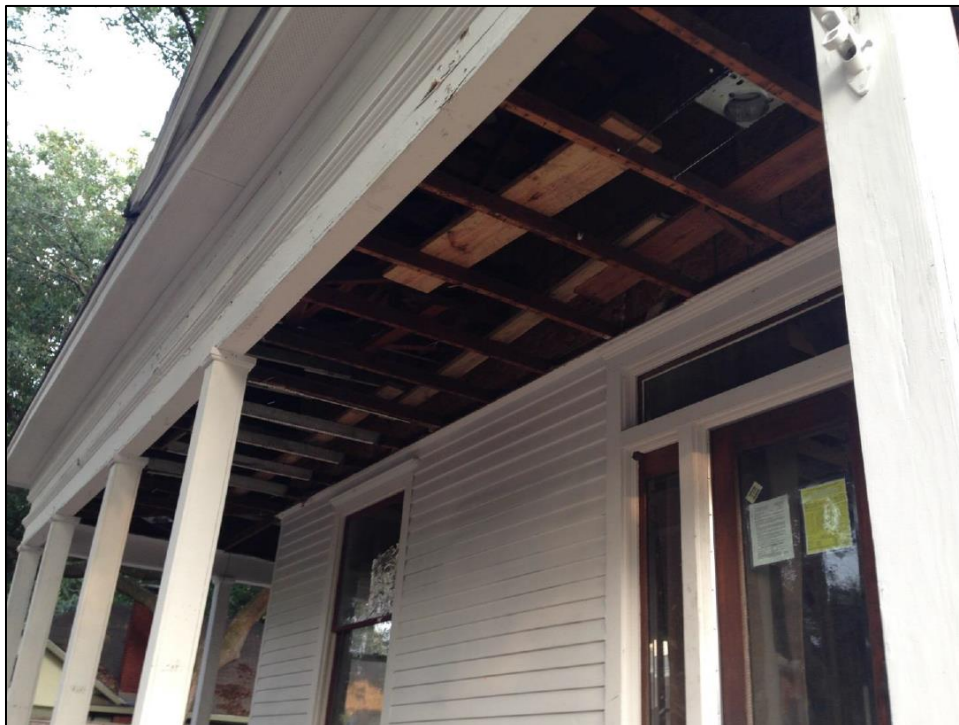
Applicant Photo; Removed beadboard porch ceiling

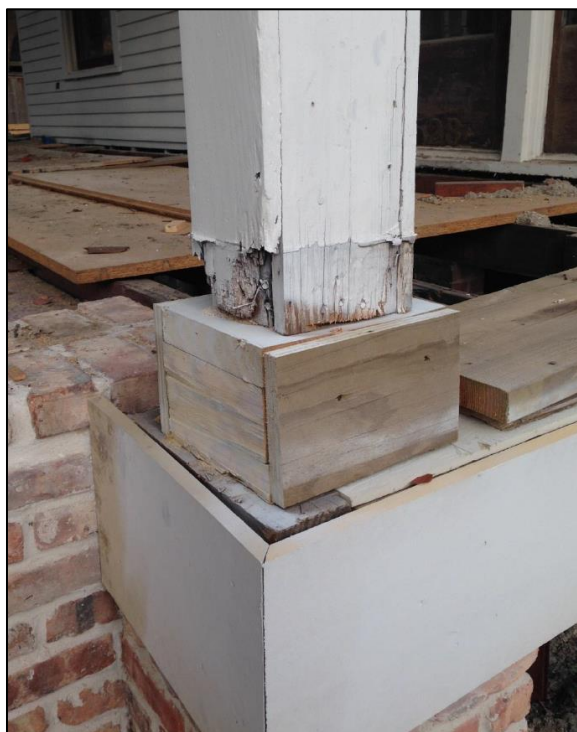
Applicant Photo; Altered porch column

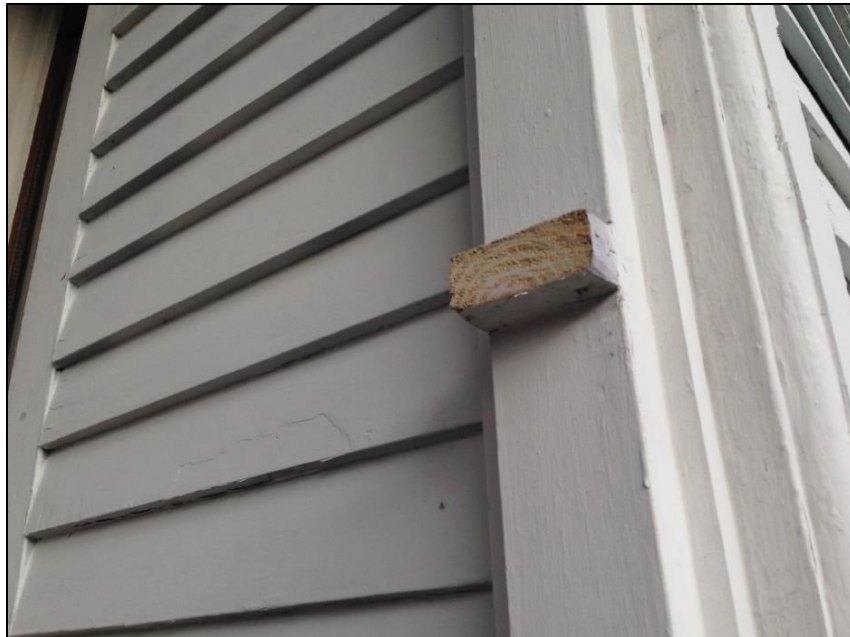
Applicant Photo; Removed original porch railings

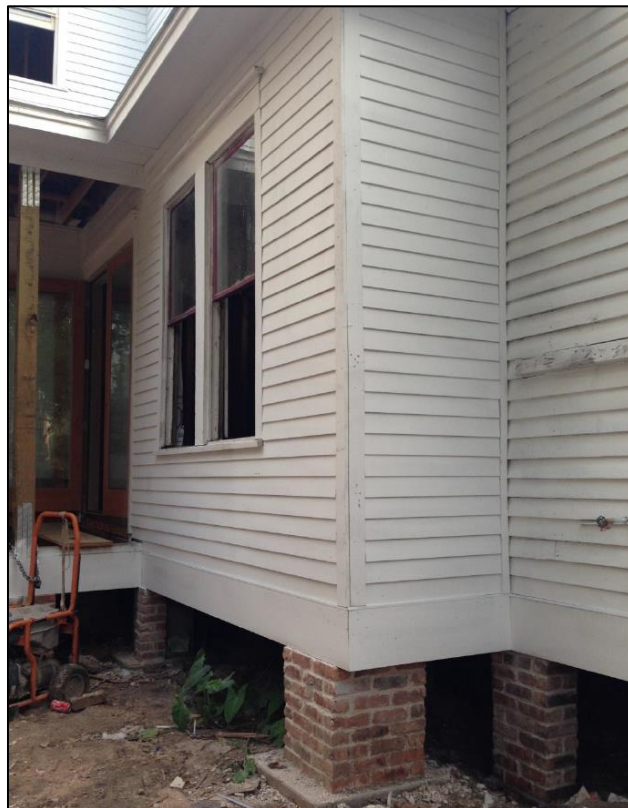
Applicant Photo; Unapproved bump-out on east elevation

- According to the applicant, the foundation company installed the piers based on the "bid set" of plans which included this portion of the addition. The final COA approved plans did not include this portion. The framer continued on with the error and it was not realized until the framing was complete.

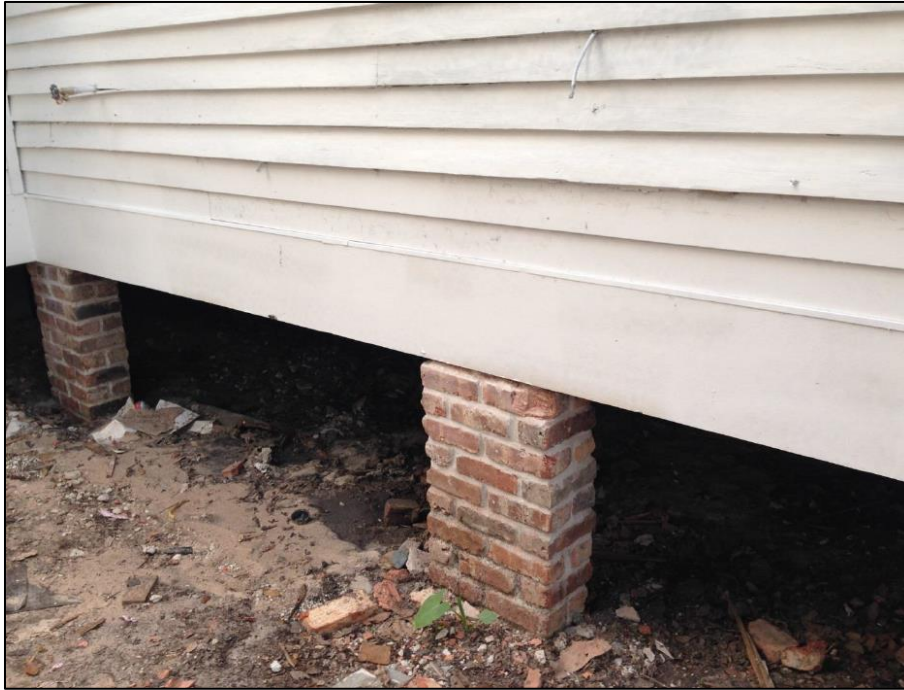
Applicant Photo; replaced boards with cementitious siding

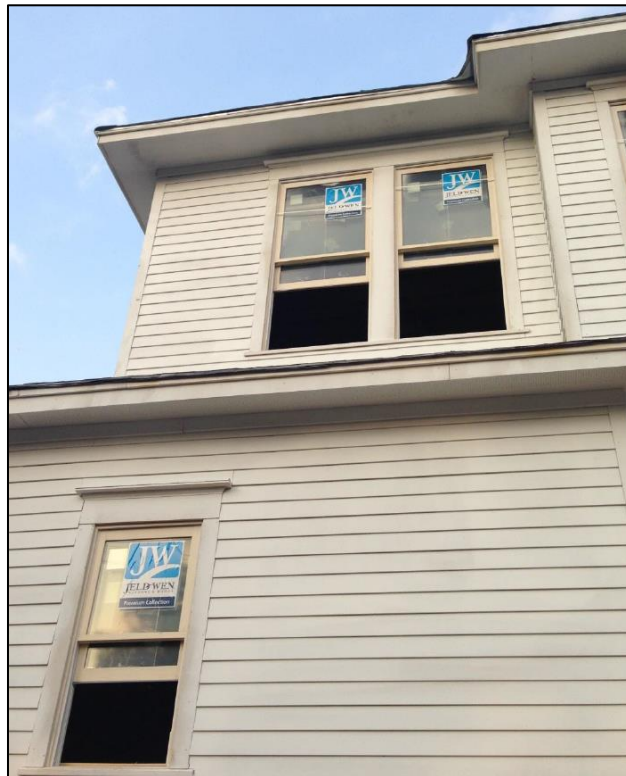
Applicant Photo; Second-story addition encroaches an additional 18" onto original house

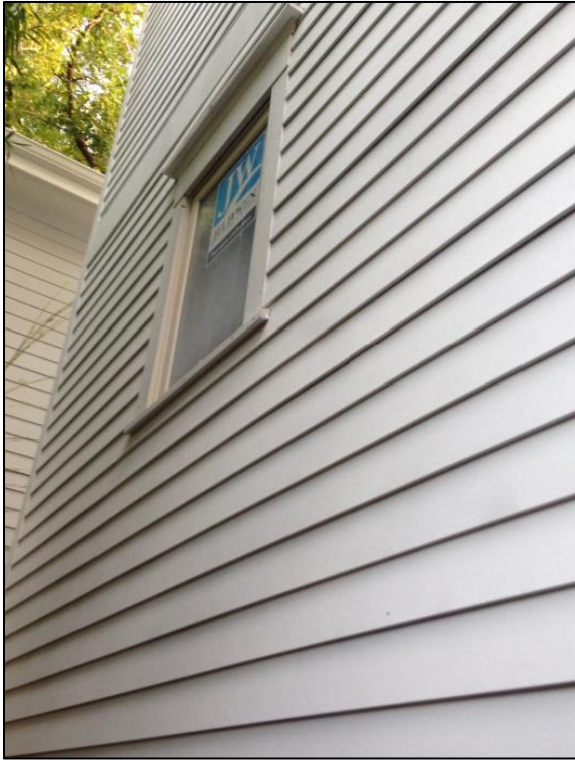
Applicant Photo; Unapproved bathroom window

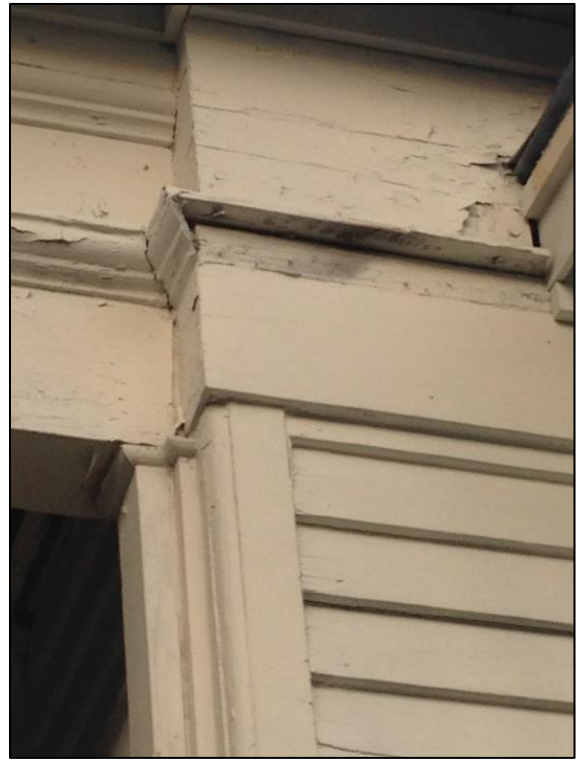
Applicant Photo; Missing/Broken trim

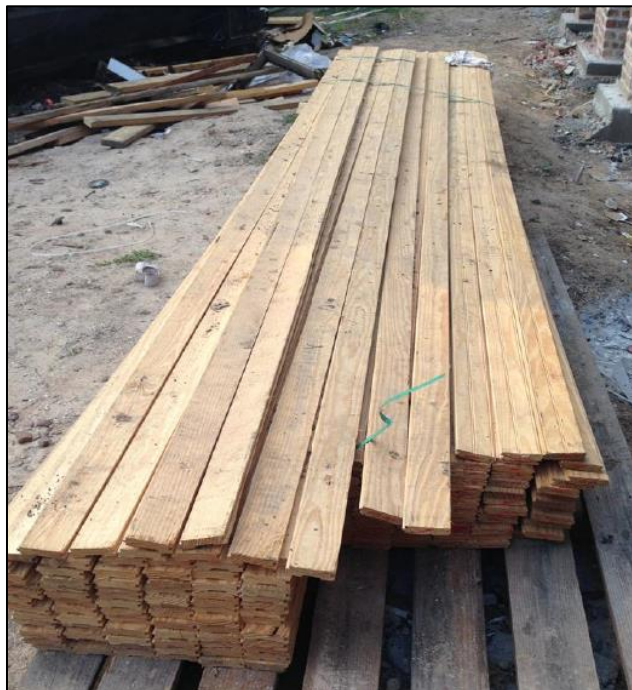
Applicant Photo; Replacement porch decking and beadboard on site

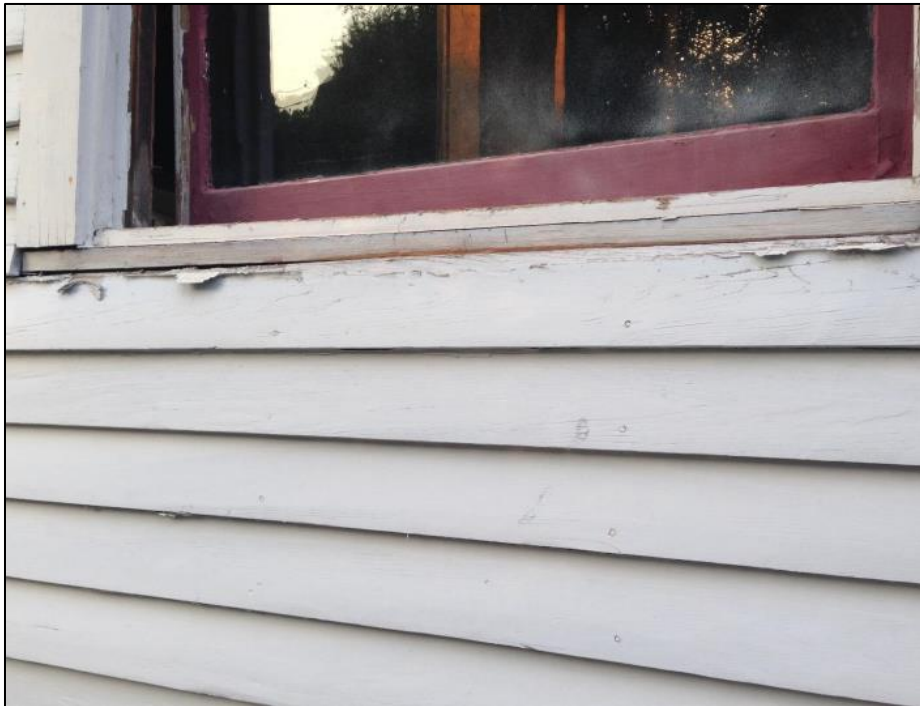
Applicant Photo; Missing/Broken window sill

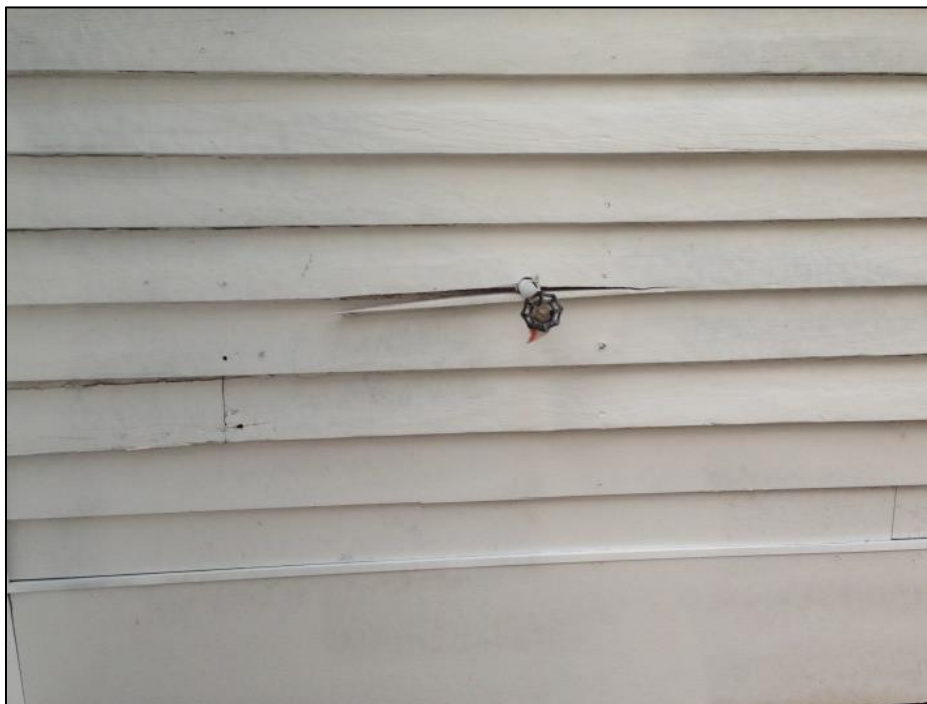
Applicant Photo; Damaged siding
